# **Applying step heating thermography to wind turbine rotor blades as a non-destructive testing method**

Christoph Nieß, Jens Fey, Daniel Schwahlen, Martin Reimann  
and Uwe Handmann  
Ruhr West University of Applied Sciences  
Bottrop, 46236, Germany  
+49 208 88254801  
uwe.handmann@hs-ruhrwest.de

## **Abstract**

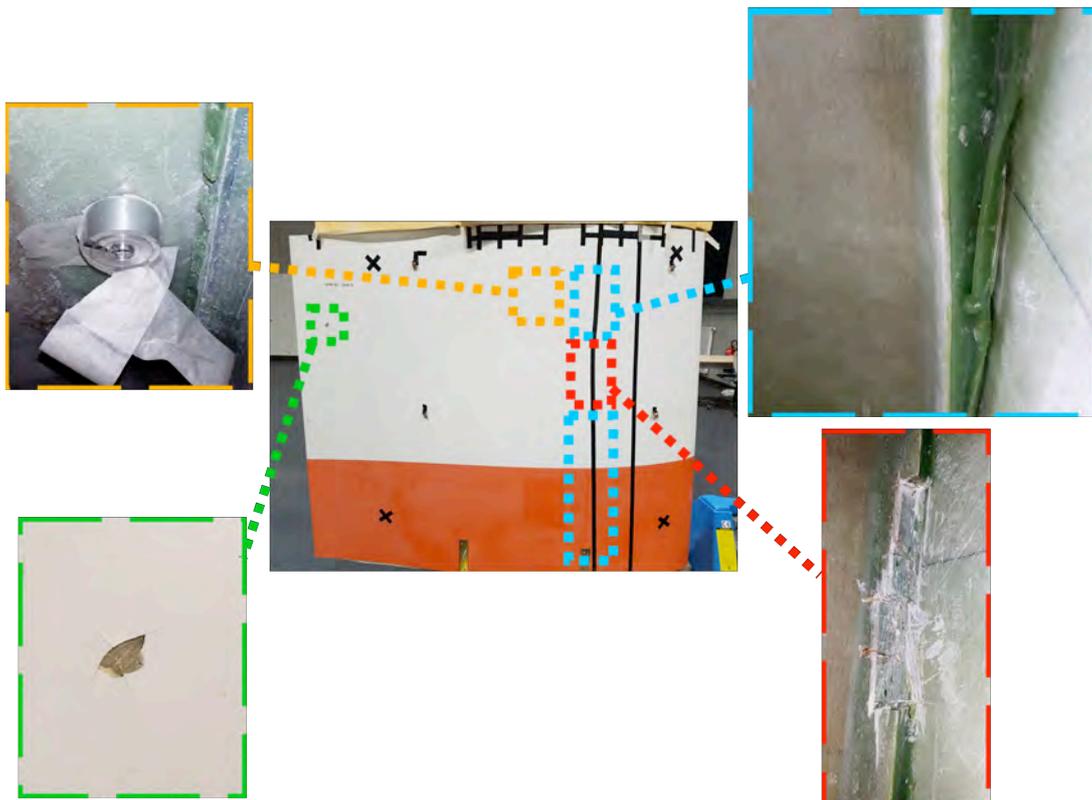
**Figure 1. Anomalies of rotor blade specimen HRW 00: Green: Chip in the gel coat; Blue: Unbonded adhesive joint; Orange: Aluminium cylinder; Red: Removed material**

All damage documented in specimen HRW 00 so far is marked in Fig. 1. A non-artificial damage is a chip in the gel-coat, marked in green. Beside this chip, a gap in the adhesive layer between the front spar cap and the shear web, marked in blue, was identified as a second non-artificial anomaly. The unbonded area starts a few centimetres below the outer cutting edge of the specimen. While it can be expected to show thermal behaviour similar to a failure of the adhesive joint (Table 1, type 1), it is a case of absent material (Table 1, type 8).

Two artificial anomalies were added during earlier experiments, a glued in aluminium cylinder, marked in orange, and an area of removed glue at the joint of the front spar cap and shear web, marked in red. Their exact specifications are described in Fey et al [4].

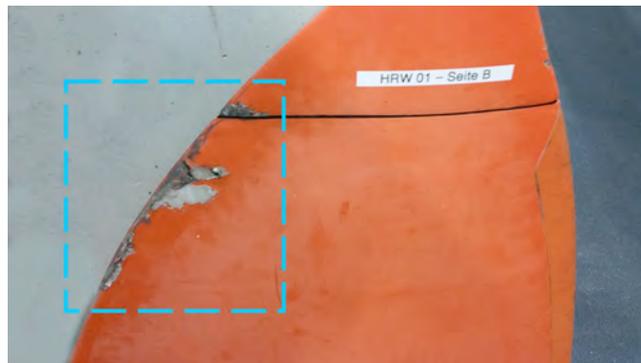
A non-artificial adhesive joint failure is located at the trailing edge of this specimen (Fig. 2). This large failure of the adhesive joint is accompanied by additional damage, such as local delaminations, cracks and chips of the gel-coat, which are not individually addressed.

**Figure 2. HRW 01. Blue: Failure of the trailing edge joint**

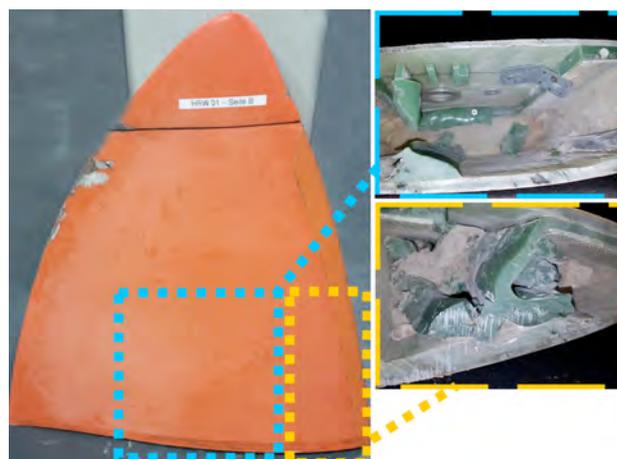
**Figure 3. HRW 01. Blue: Foreign objects; Orange: Excess glue**

A look at the inside of the specimen reveals the rough processing of the adhesive joint in the wingtip. This is due to technical difficulties during the manufacturing process and can to some degree be expected in every rotor blade. A few centimetres above the

Three pieces of glue from the adhesive joint of the rotor blade that were found in the specimen were glued to the inside of the shell. Further out, two metal rings of different diameter were also glued in, with an additional drop of glue left between them. A metal bracket was screwed in, positioned so only its tip is in contact with the inner surface of the shell. Both areas are marked in Fig. 3.

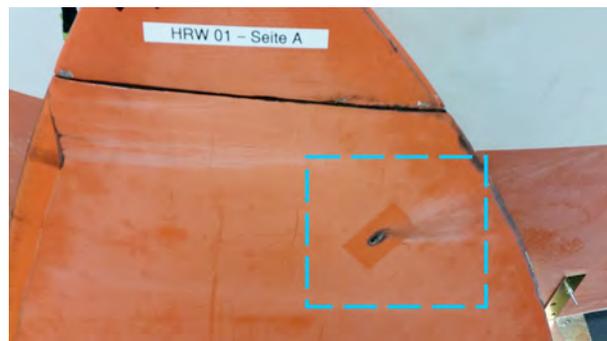
While some anomalies are indicators of damage or structural weaknesses, others can be intended to be a part of the blade. An example for that is the water outlet shown in Fig. 4. This water outlet is situated a few centimetres from the metal end of the tip.

**Figure 4. HRW 01. Water outlet**

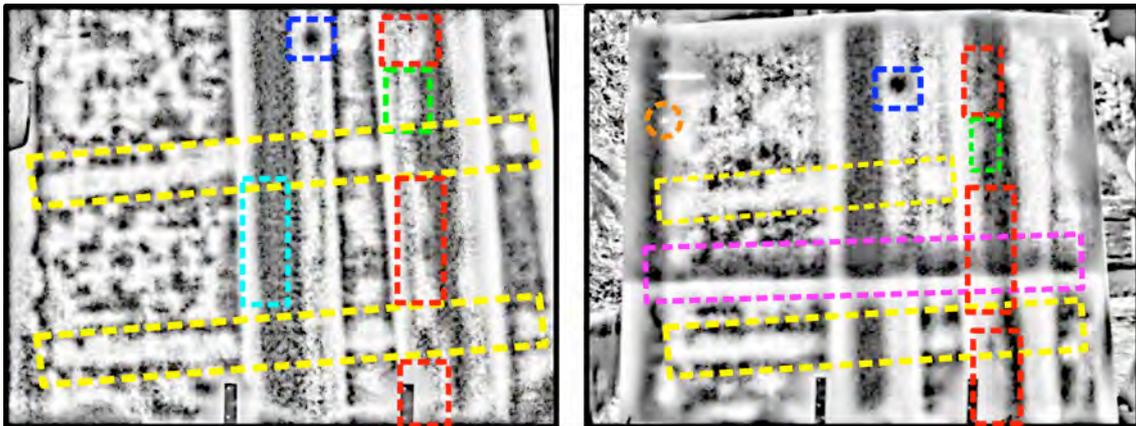
The first visible feature is the aluminium cylinder glued to the inside of the back spar cap (Fig. 5, marked in blue). It is clearly visible in both the laboratory and the outside test, even though it is mounted behind the 20mm thick layer of glass fibre composite. Its diameter in the infrared image appears smaller than its physical diameter due to lateral heat diffusion, but equally so for both setups.

Also clearly visible are the large unbonded areas of the front spar adhesive joint (multiple areas marked in red). Their visibility differs slightly in the outside tests, with better results for the orange painted areas of the wing surface. Again, the depictions of the glue joints are slightly smaller than the actual structures due to diffusion, but the form and appearance (straight edges for the well-made back spar, marked in light blue, wavy edges on the faulty front spar) is well preserved.

The sawed-out part of the glue joint is visible as well, with the same side effects as the original areas of missing glue.

Two warmer areas of unknown origin are visible in both test setups (marked in yellow). While it can be assumed that they might be areas of overlapping fibre mat pieces, only destructive testing will provide conclusive evidence. As further non-destructive testing of the specimen is planned, this was postponed.

Only visible in the outside test is the transition from the orange painted surface area to the white area (marked in purple). A dependency on the spectrum of the excitation light source can be suspected, but must be clarified by further specific tests.

**Figure 5. Visible features of specimen HRW 00 in the laboratory setup (left) and in an outside test (right). Blue: Aluminium cylinder; Red: Unbonded glue joint; Light blue: Intact glue joint; Green: Sawed-out material; Yellow: Unknown subsurface structure; Purple: Edge of the orange safety marking; Orange circle: Gel-coat chip. Image processing was applied.**

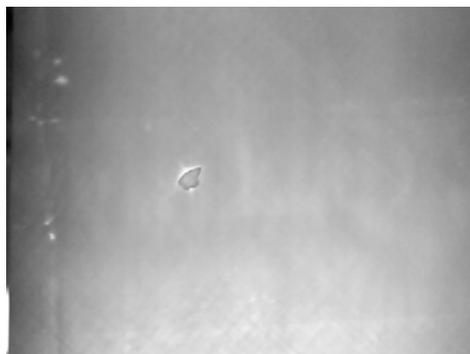
As well as the transition of orange and white paint, the small chip in the gel-coat (marked in orange), could only be detected outside with this type of setup. Therefore, a new experiment with different setup parameters was performed. In this new setup, just one IR-Lamp was used to apply a short, intense heat pulse to a small area. The thin layer of debonded material reacts very quickly and intensely to applied heat. In addition, it rapidly cools when the heat flow is turned off. Pictures taken immediately after the short heating period expose those areas with high contrast. With a short heating period and little time for lateral heat diffusion, the image is very sharp but only shows structures close to the surface. Those same conditions also expose a rhombic pattern that can be attributed to the weaving of the outermost glass fibre mat layer. Fig. 6 shows a close up of the chip and surrounding area.

**Figure 6. HRW 00. Effects of a short heat pulse**

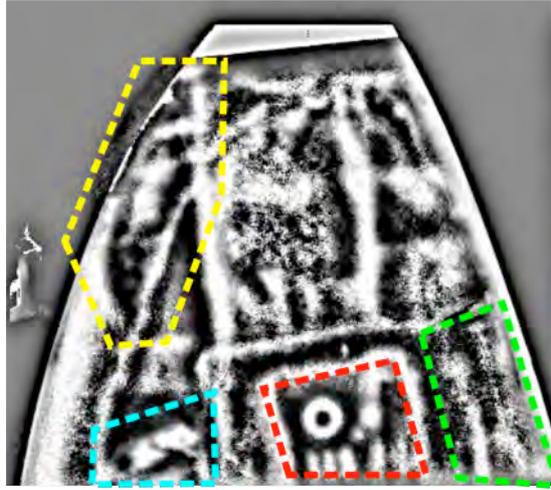
**Figure 7. Visible features of HRW 01. Red: Foreign objects; Green: Excess glue; Light blue: Thicker material at the edge of the core material; Yellow: Adhesive joint failure at trailing edge. Image processing was applied.**

Clearly visible in direct observation as well as the thermal images, is the failed glue joint at the trailing edge (Fig. 7, marked in yellow). The failure is visible as a dark area and clearly structured. This structure could be confirmed with a thin metal probe: Part of the failure (the lower part in Fig. 7) can be probed to the inside, while other areas (the middle part in Fig. 7) are blocked after a short distance.

Interestingly, the green marked area of the adhesive joint and excess glue is indistinguishable from other, not obviously structured areas.

In contrast to this, the picture allows a clean view on every single object attached to the inside of the specimen (area marked in red), even the thin drop of glue.

The intense anomaly between the back spar and the trailing edge (marked in blue) appears to be a thicker area of fibre mats and glue at the transition from the core material to a thinner, fibre reinforces plastic only shell at the outer tip. As with the unknown anomalies in HRW 00, this will have to be examined destructively after non-destructive testing has been finished.

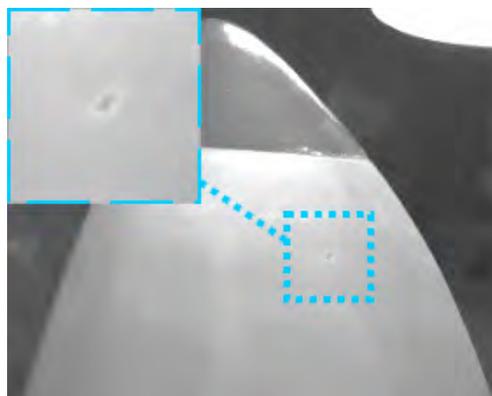
**Figure 8. HRW 01. Water outlet**

Like explained in 4.2, not every irregular structure in the rotor blade, necessarily has to be damage. Some of those structures are just architectural features of the wind turbine. This includes the water outlet shown in Fig. 8
