Increasing Economic Viability and Safety Through Structural Health Monitoring of Wind Turbines

Daniel Schwahlen, Jens Fey, Christoph Nieß, Martin Reimann and Uwe Handmann
 Ruhr West University of Applied Sciences
 Institute of Computer Science
 Bottrop, Germany

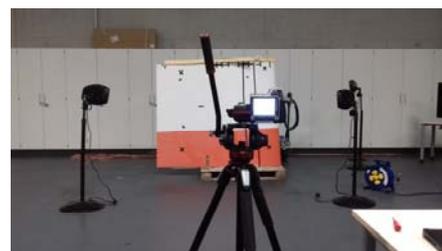
Figure 3. Laboratory setup

directions. The lamps can be positioned freely and have the option to adjust their heating power. Therefore, it is possible to simulate different sun intensities and try to get the heating as homogenous as possible. The exact configuration of the setup is shown in Fig. 2 and Fig. 3.

The experiments are a continuation of previous work described in [7]. To generate a heat flow into the rotor blade, the specimen was heated up with the IR-lamps. The duration of the heating phase was adjusted to show deeper structures instead of details right beneath the surface. After turning off the IR-lamps, the heat flow naturally changes to flow out of the specimen. Ultimately, these heat flows open up the possibility to visualize the structure of the rotor blade. To monitor the results a continuous sequence of thermal images was recorded, including both the heating up and the cooling down periods.

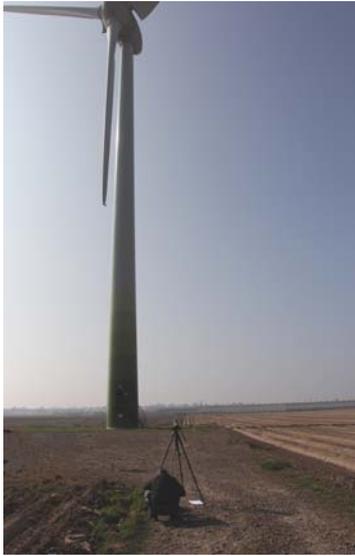
Figure 4. On-site test setup

To transfer the laboratory experiment onto an on-site wind turbine, the test procedure had to be modified to accommodate the conditions. The first difference is the considerably larger size of the complete wind turbine compared to the laboratory sample. As a consequence the distance between the camera and the rotor blade of the wind turbine plant is increasing as well, so a different lens had to be used. Due to availability a different

camera was used in the tests, a FLIR A655sc. The resulting on-site testing setup is shown in Fig. 4.
